# Aurora<sup>®</sup>

Track Inspection  
Technology

## Turn tie inspection into savings and safety.

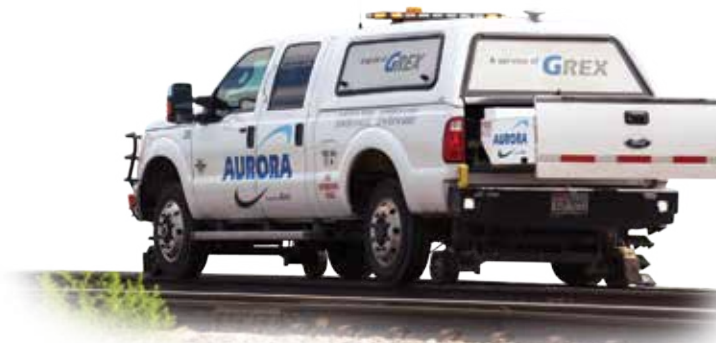
Over time, Rail Seat Deterioration (RSD) can cause a crosstie to no longer support and restrain the rail. Aurora® uses advanced shape recognition to identify degraded concrete ties for repair or replacement.

- Measures RSD and pad wear
- Assesses fasteners and insulators
- Meets industry inspection requirements

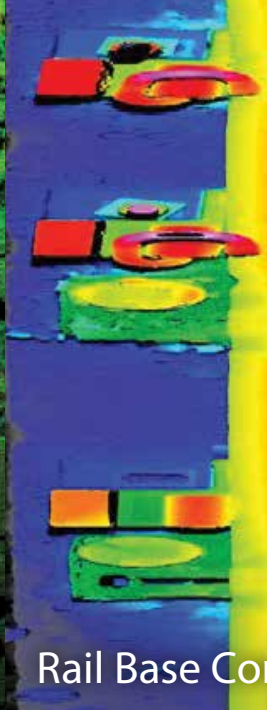
Rail Base Corrosion Assessment

Chipping, cracking and splitting are usually telltale signs of Rail Base Corrosion (RBC), most commonly found in tunnels. Aurora® can assess the severity of RBC by continuously measuring the width of the rail base.

- Identifies critical loss of rail base
- Evaluates rail base chip depth and shape
- Assigns grade to RBC severity
