The Capabilities and Economics of Specialty Ballast Excavation

Advanced Methodology and Techniques for Specialty Ballast Remediation on MRS Railway

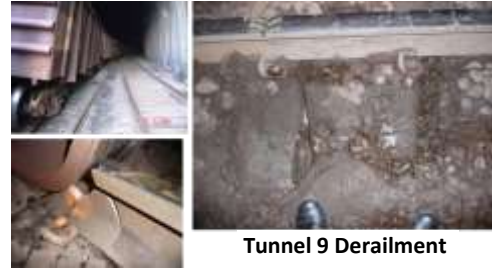
Tunnel 9 Derailment

MRS Logistica realized it was time to find a better method of rehabilitating their Specialty Trackwork following a 2009 derailment in Tunnel 9 (see insert to right) caused by a broken rail as a result of ineffective ballast and drainage maintenance.

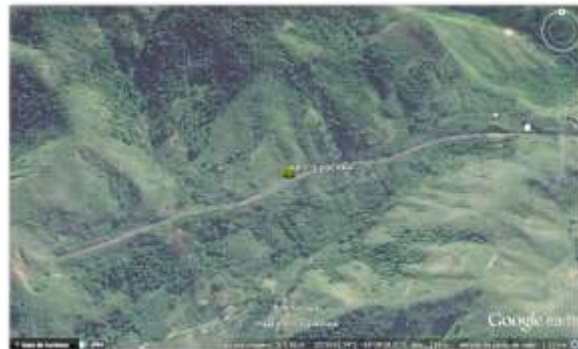
Work Location on June 1

**Km71+445 to 71+307 between the tracks = 34.5m³
in 60 minutes**

**Km71+445 to 71+429 right shoulder = 4.5m³
in 11 minutes**

**TOTAL = 39m³ in 1h11minutes – 2 full dumpings
(7 min each dump)**

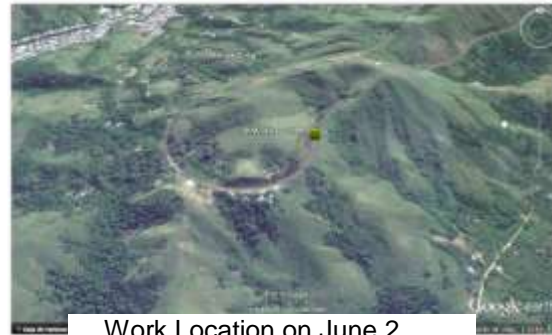
Work Location on June 2

Right shoulder - km74 + 232 to 74 + 070

Left shoulder - km74 + 172 to 74 + 018

Total = 91m³ and 7 dumpings

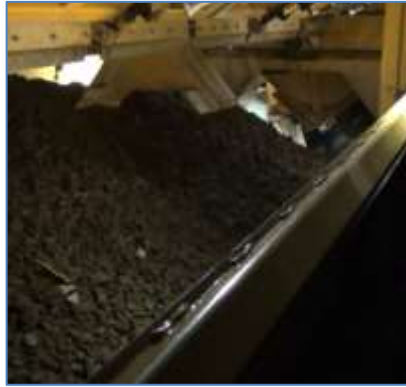
Waste - Onboard

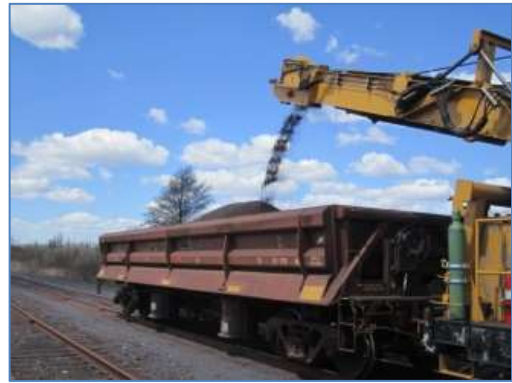
Waste to Material Handling Car

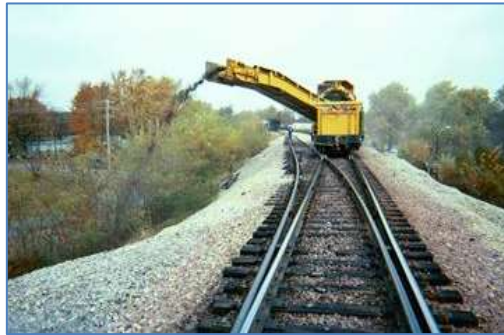
Waste to Right of Way

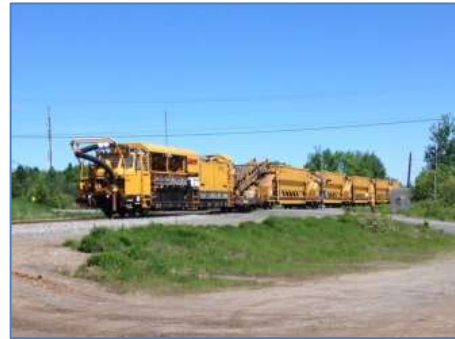
Pulling 4 Material Handling Cars

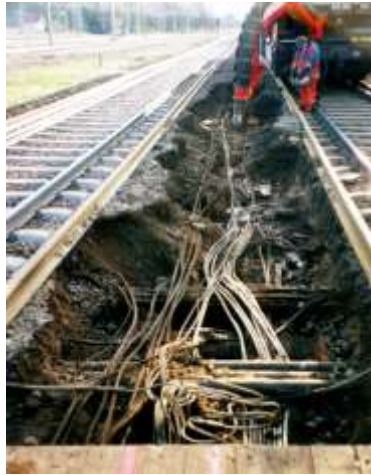
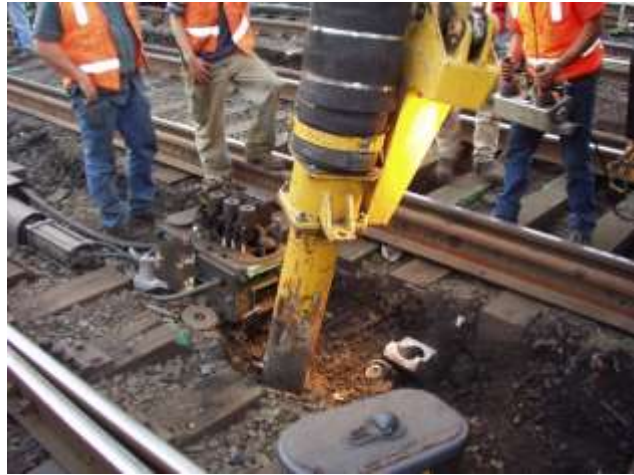
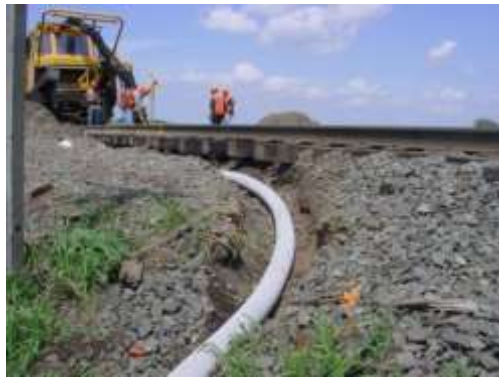
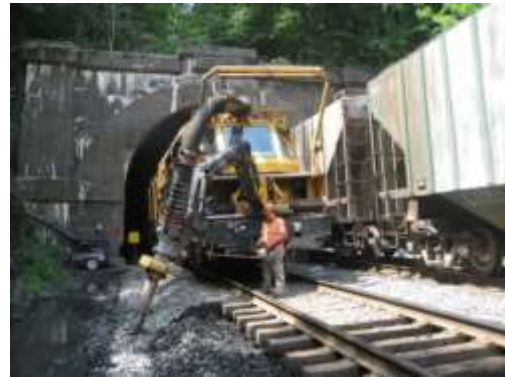
6. Examples of uncovering buried communication wires, trenching, and drainage work

The Railvac can also be used to dig trenches to drain water away from the track and into a drainage ditch. It can also dig trenches alongside the track or under the track to bury wires and cables. The Railvac can be used to uncover buried wires and cables without damaging them. The Railvac is great at cleaning up debris in yards and other areas where trash and debris accumulate. (See Appendix E for pictures of other Railvac activities)

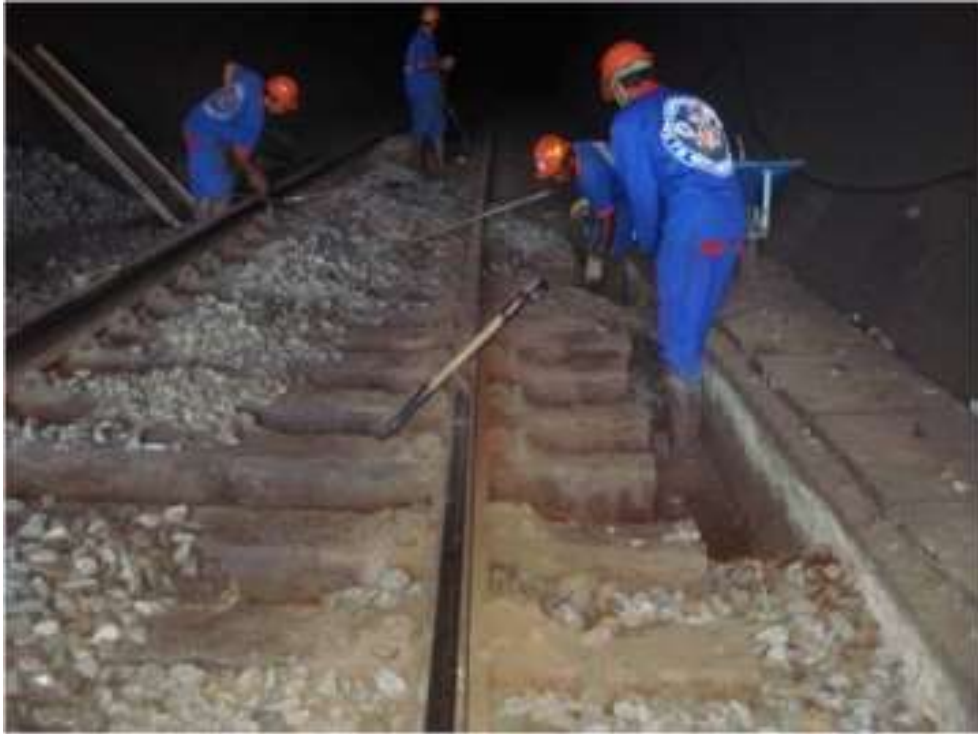
Traditional Method

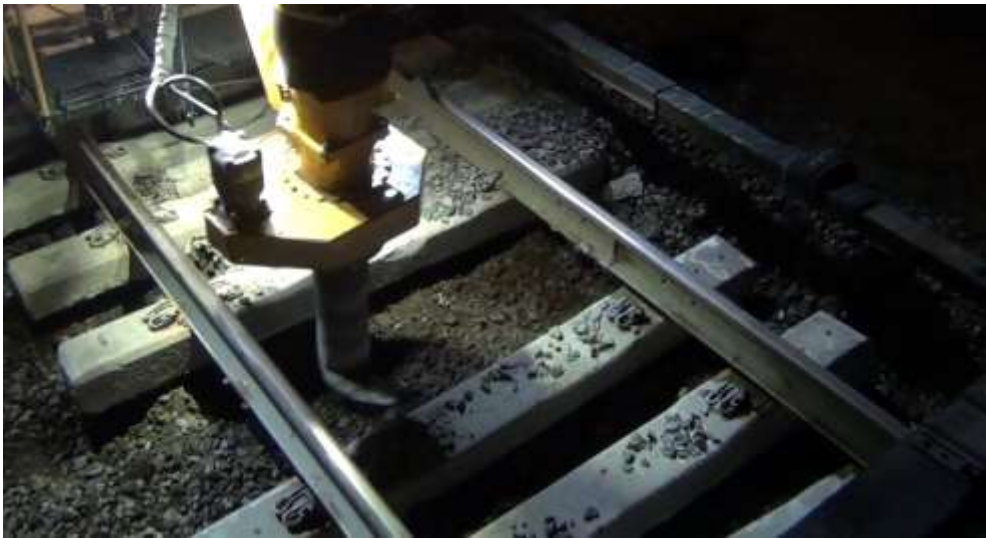
Mechanized Method

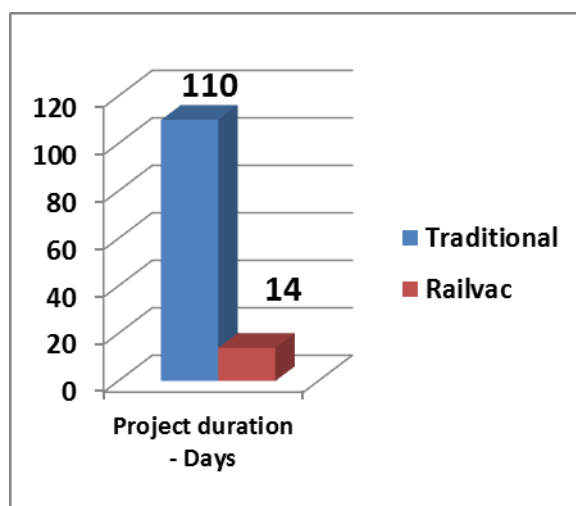
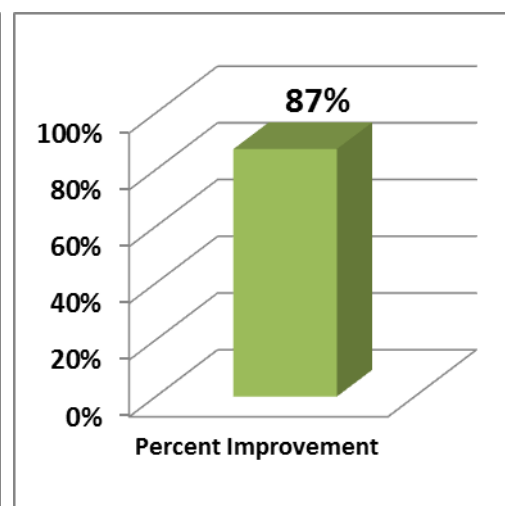
2. Project Duration Comparison

Traditional	Railvac	% Improvement Railvac vs. Traditional
Project duration - Days	110	14	87%

This represents an 87% improvement in the number of days, a 76% reduction in the number of people required, and the total cost of the project improved by 78%. The cost savings for the project was R\$740,210 (\$233,910 USD).

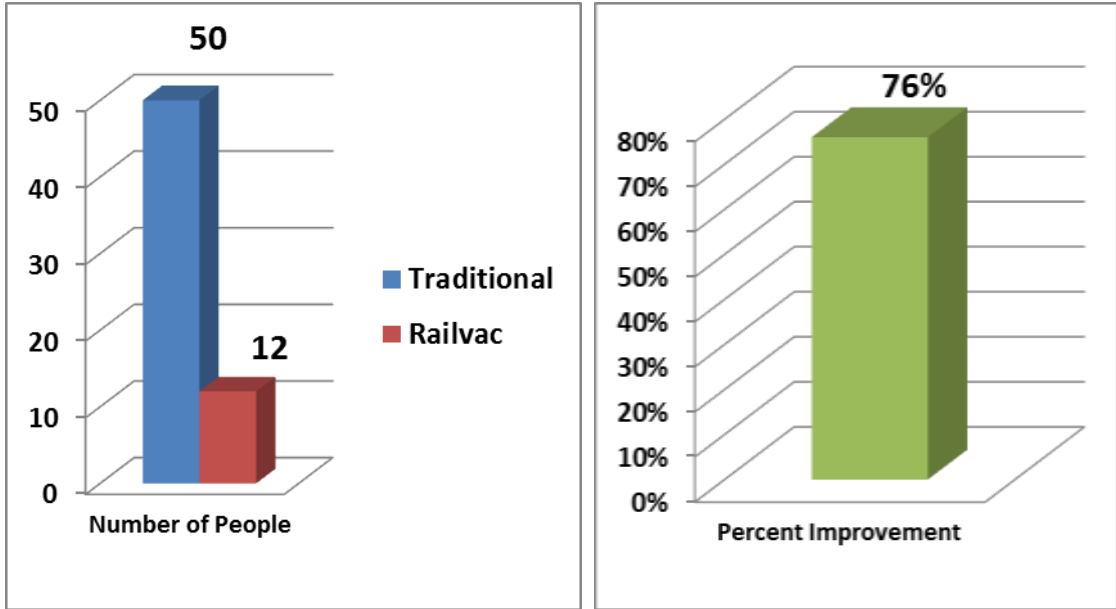
3. Manpower Requirements Comparison

Traditional	Railvac	% Improvement Railvac vs. Traditional
Number of Employees	50	12	76%

MRS estimated an increase of 60% in productivity from 20 m³/hr. (65.5 ft.³/hr.) to 32 m³/hr. (105 ft.³/hr.) plus a 76% reduction of manpower. MRS had been using 50 people under their traditional method and they estimated 12 people would be required with the Railvac.

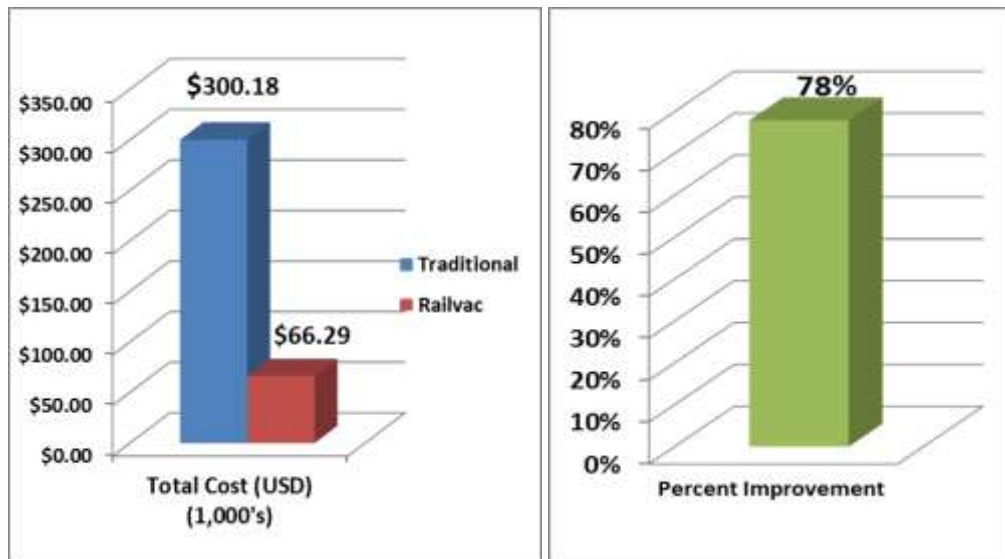
4. Total Cost Comparison

Traditional	Railvac	% Improvement Railvac vs. Traditional
Total Cost (USD) (1,000's)	\$300.18	\$66.29	78%

Using the Railvac on the same tunnel of 2,233 m. (1.39 mi.) of track and 8 hour duration days changed the economics considerably. The project was completed in 14 days. The number of people used with the Railvac project was 12. The total cost of the project, using the Railvac, was R\$209,790 (\$66,290 USD).

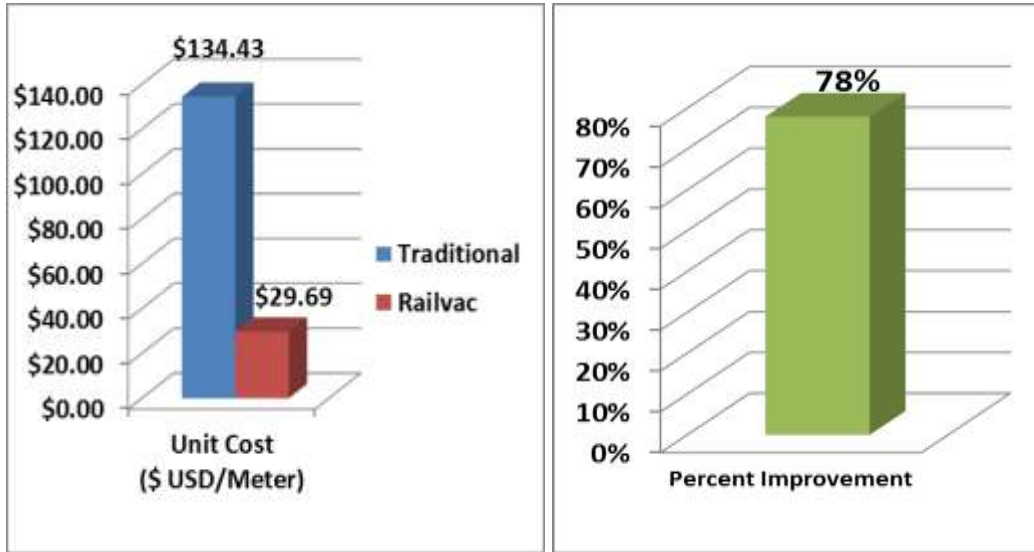
5. Unit Cost Comparison

Traditional	Railvac	% Improvement Railvac vs. Traditional
Unit Cost (\$ USD/Meter)	\$134.43	\$29.69	78%

MRS estimated the unit cost of the Railvac at R\$ 93.95 (\$29.69 USD). This included the depreciation cost of the Railvac, operating expenses and wages of 12 people. Under MRS' traditional method the unit cost ranged from R\$ 155.13 (\$ 49.02 USD) on the low end up to R\$ 425.44 (\$ 134.43 USD). This range was dependent on the complexity of the ballast replacement work being completed. The average unit cost under the traditional method is R\$ 290.29 (\$ 91.73 USD). Comparing the average unit cost under the traditional method against the estimated unit cost of the Railvac results in a per unit savings of R\$196.34/m³ (\$62.04 USD/m³). With an annual production estimate of 12480 meters (40945 feet) the

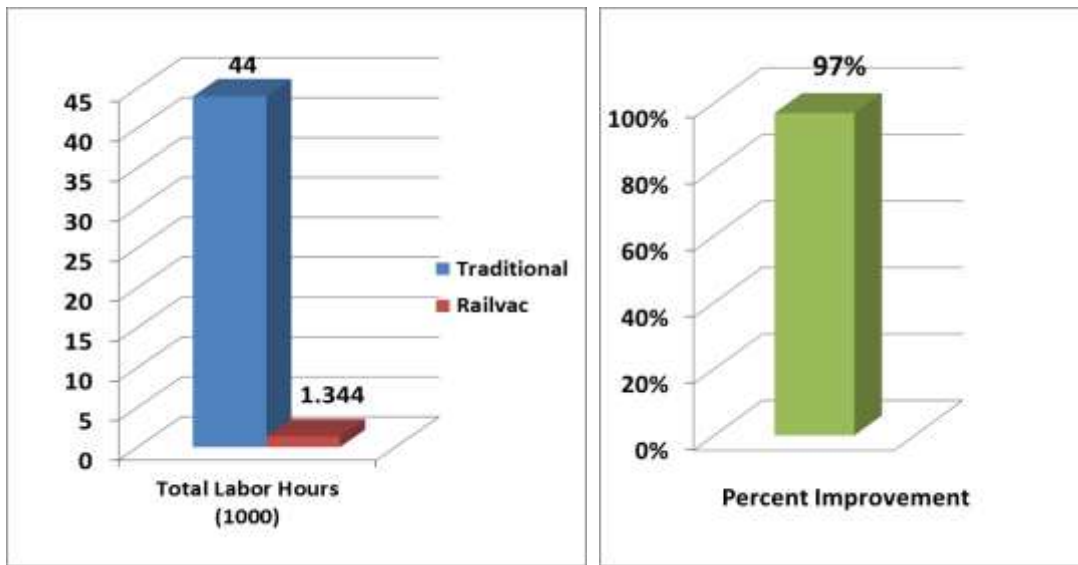
6. Total Labor Hours Worked Comparison

Traditional	Railvac	% Improvement Railvac vs. Traditional
Total Labor Hours (1000)	44	1.344	97%

The total hours worked with the Traditional Method was 44,000 hours (8 hour days; 110 days; 50 people) as compared to 1,344 hours (8 hour days; 14 days; 12 people) using the Railvac. Productivity calculated as meters completed per hour worked improved 3,174% from 0.051 m/hr. to 1.66 m/hr. (See Appendix C for Economic Comparisons between Traditional Method and Railvac Method)

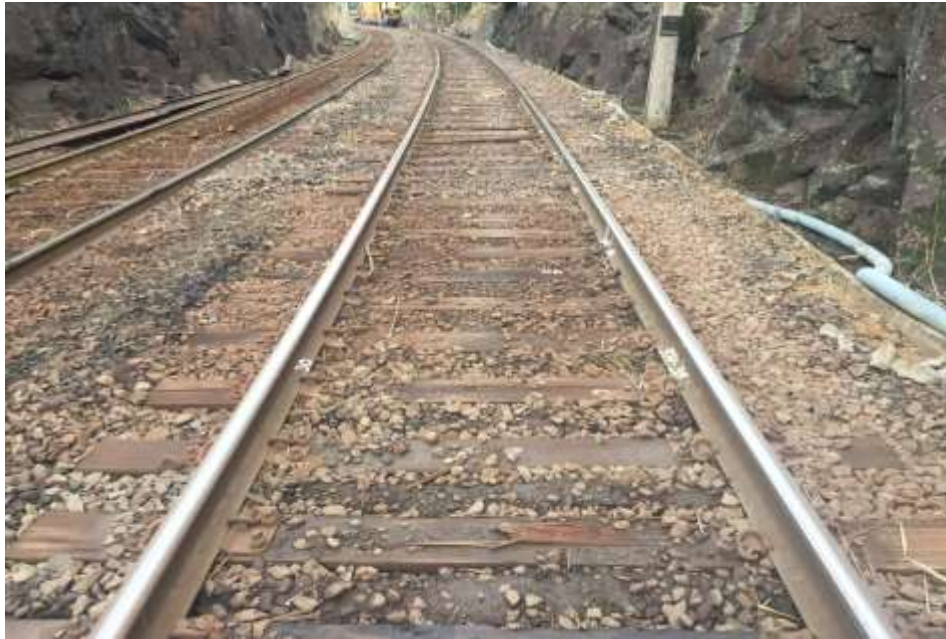
1. June 1, 2015; Km71+445 to 71+429

Before – June 1, 2015

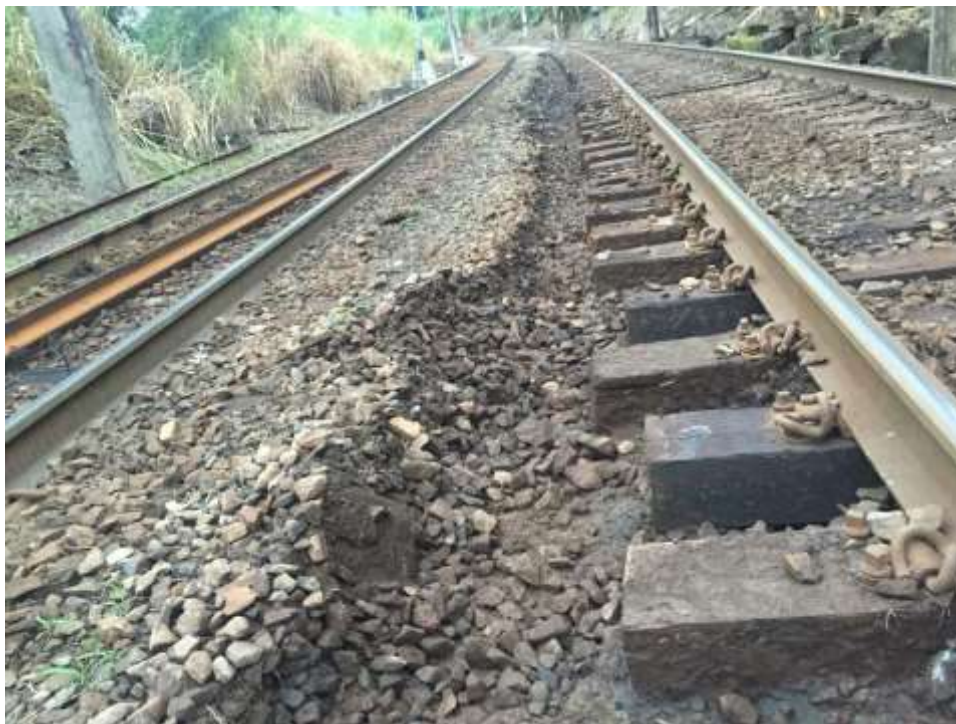
After Ballast Excavation - June 1, 2015

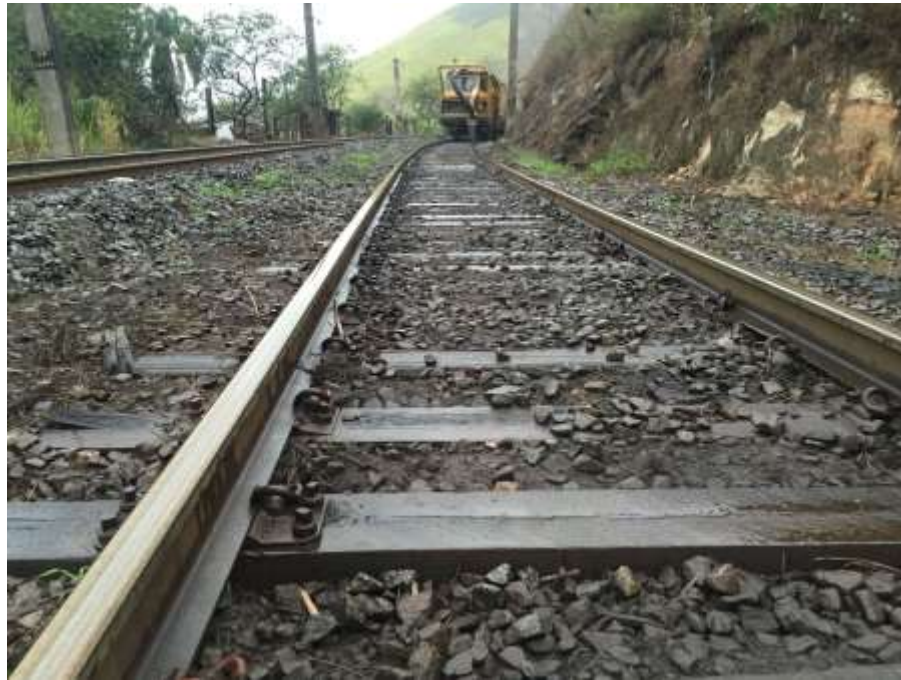
2. June 2, 2015; km74 + 232 to 74 + 018

Before – June 2, 2015

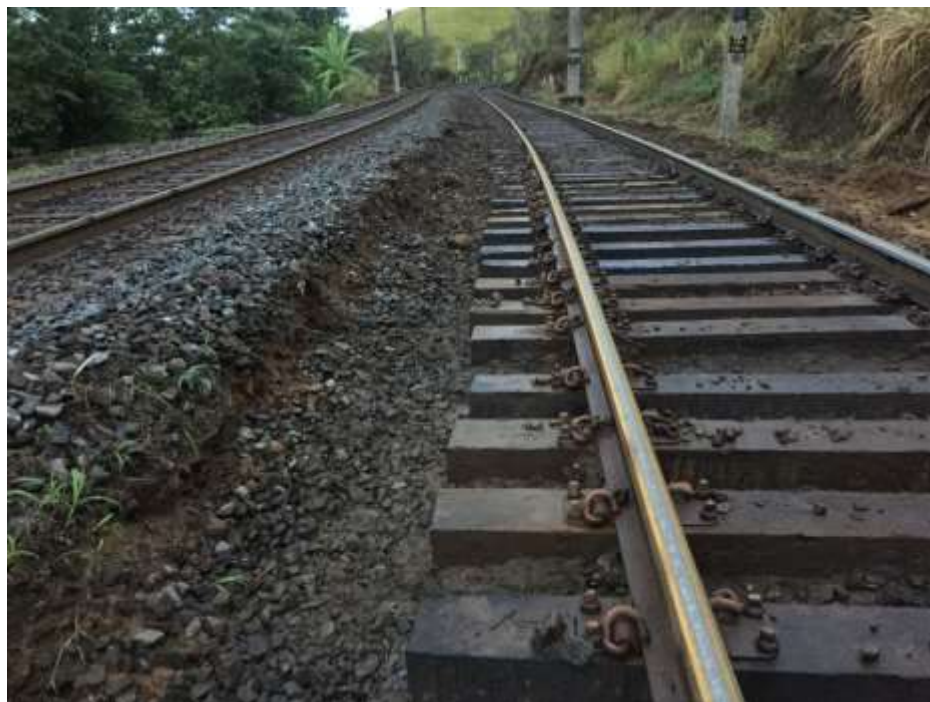
After Ballast Excavation – June 2, 2015

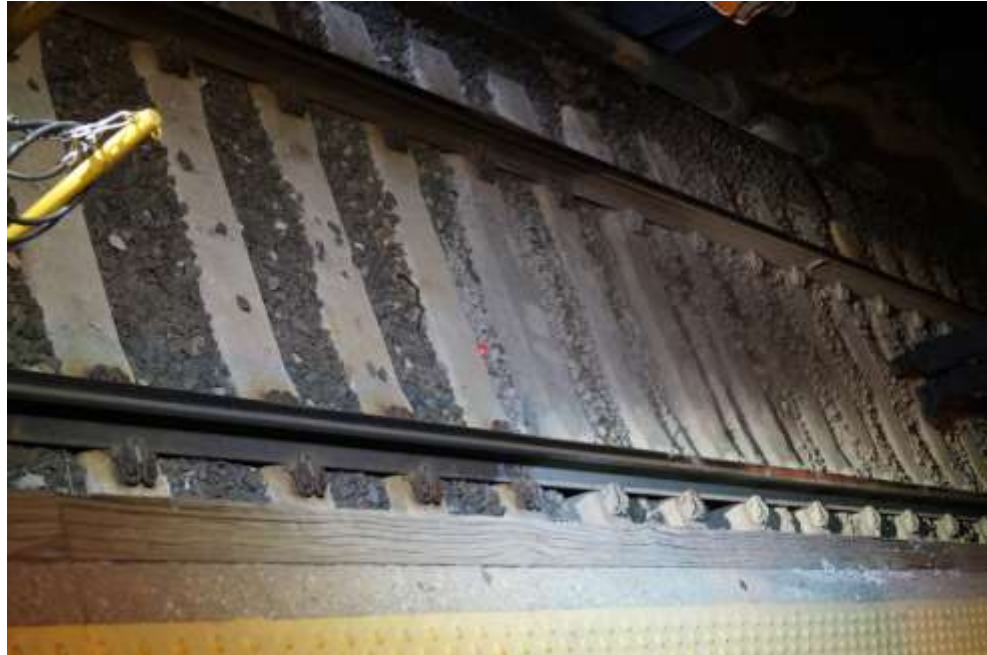
Condition Before Undercutting

In April, 2015 a Loram customer had a mud spot next to a platform on third rail electrified track. The length of track requiring ballast renewal was 7.5 m (24.6 ft.). The project scope included travel from tie-up spot to work location, de-energizing the third rail, unfastening the third rail from the ties, unloading new ties and associated hardware, undercutting the mud spot site, removing old ties and subsequent tie replacement, loading old ties on to truck crane bed, reattaching the third rail, ballast replacement, tamping, reenergizing the third rail, travel back to tie up spot and unloading hopper. The work window to complete this project was 4.5 hours.

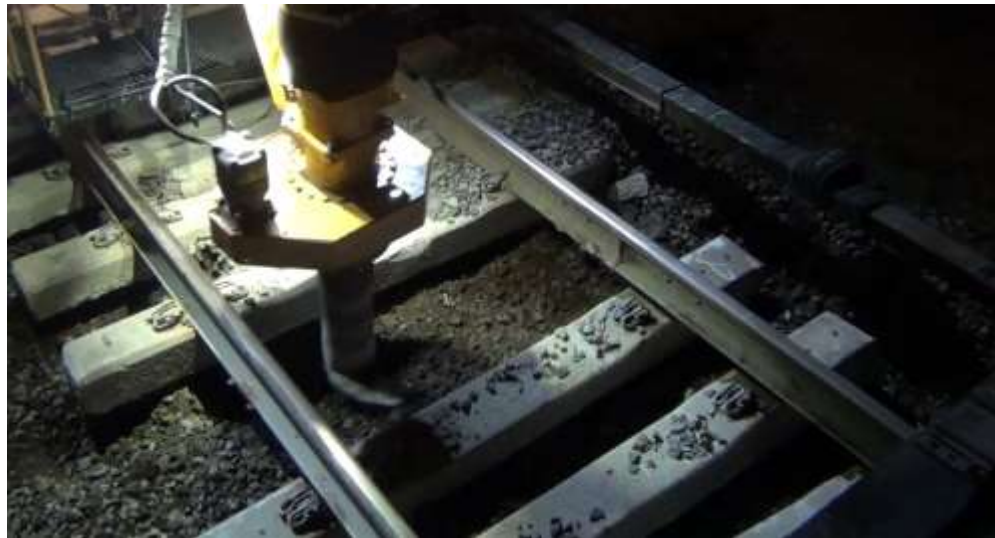
Railvac Undercutting-Notice Third Rail and Dropped Ties

Loram did a full undercut including the removal of the fast clips on the ties, dropping the ties from the rails, pushing the old ties onto the right-of-way and staging the new ties under the rail for installation. The work crew was able to safely install ties as the Railvac was completing the undercutting work, giving the Project Leader sufficient time to complete the job within the time limits. All of this work was done in 1 hour. Another 30 minutes was required to unload and tamp the new ballast. (See Appendix E for pictures of work).

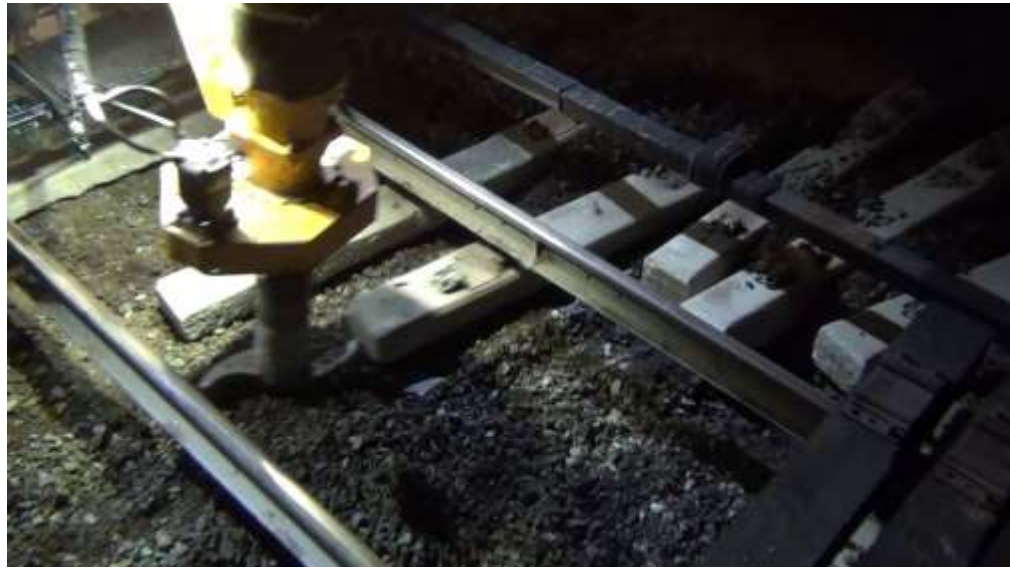
Railvac Sliding Dropped Ties onto Right-of-Way Under Third Rail

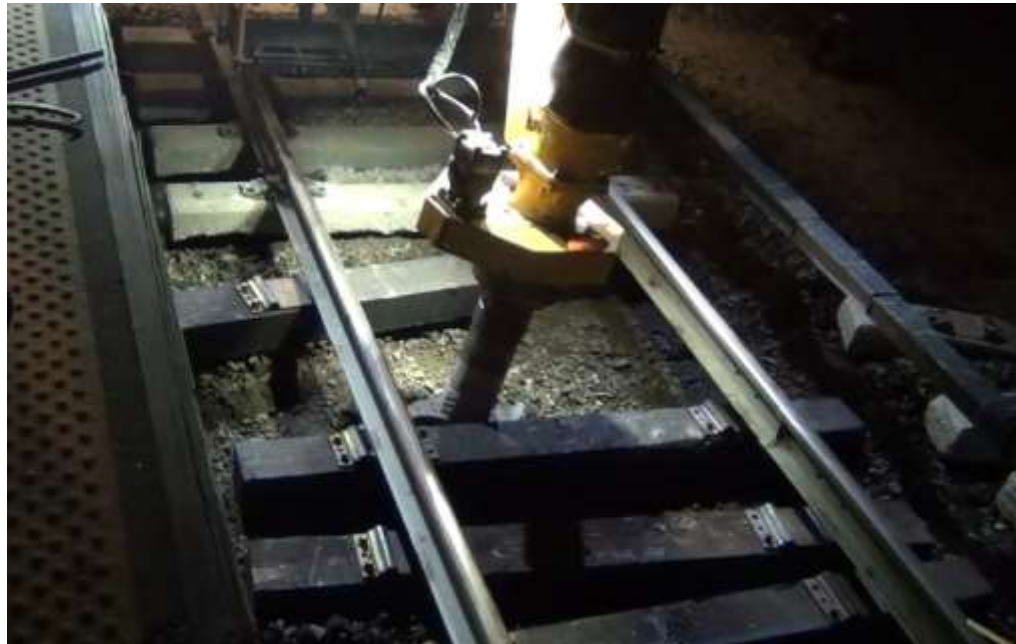
Railvac Staging New Ties Under Rails for Installation

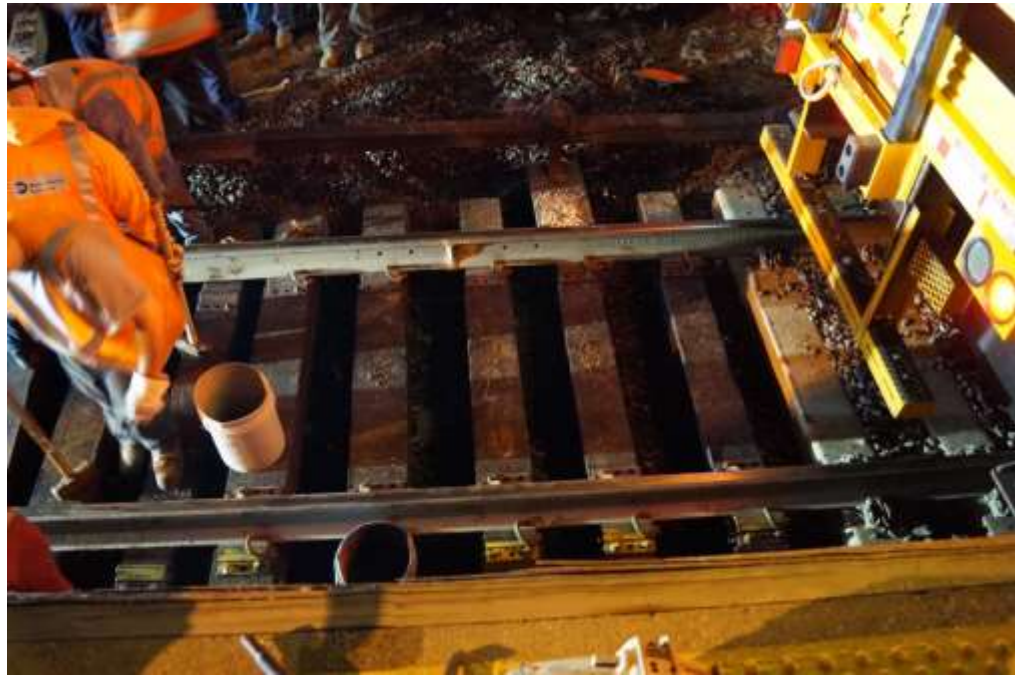
New Ties Being Secured to Rails and Reattaching Third Rail

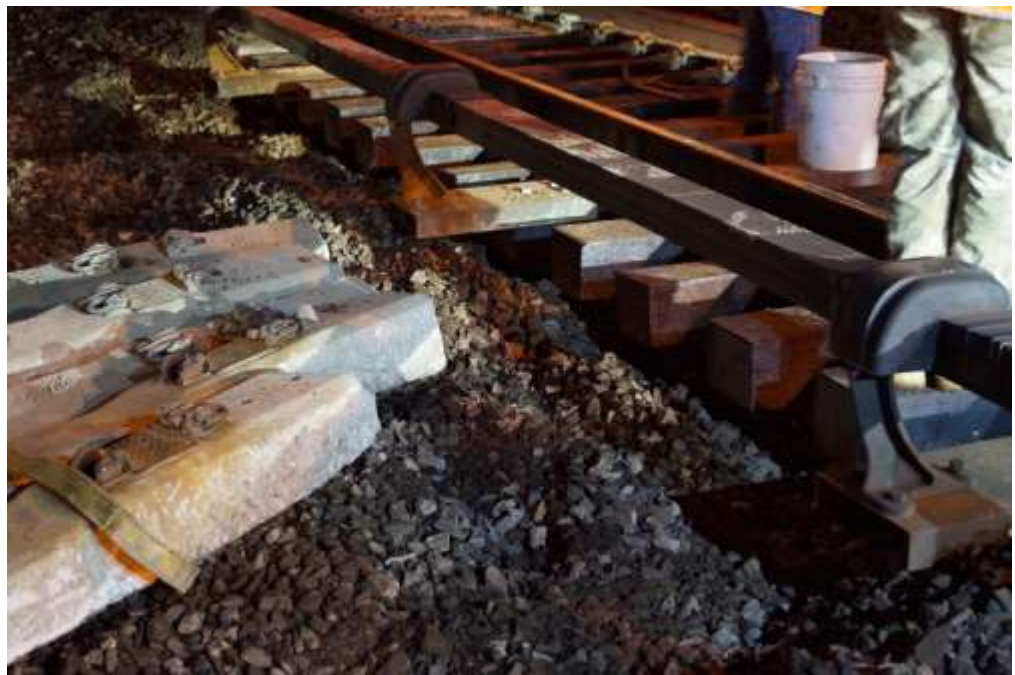
Track Waiting for Removal of Old Ties, New Ballast and Tamping

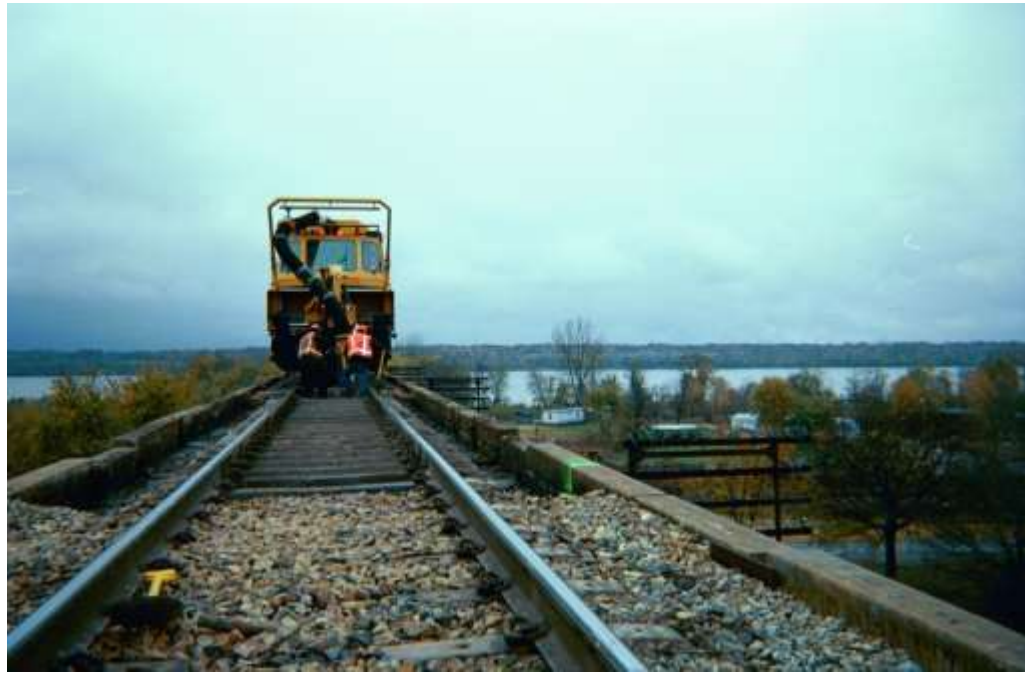
Undercutting Bridge Deck

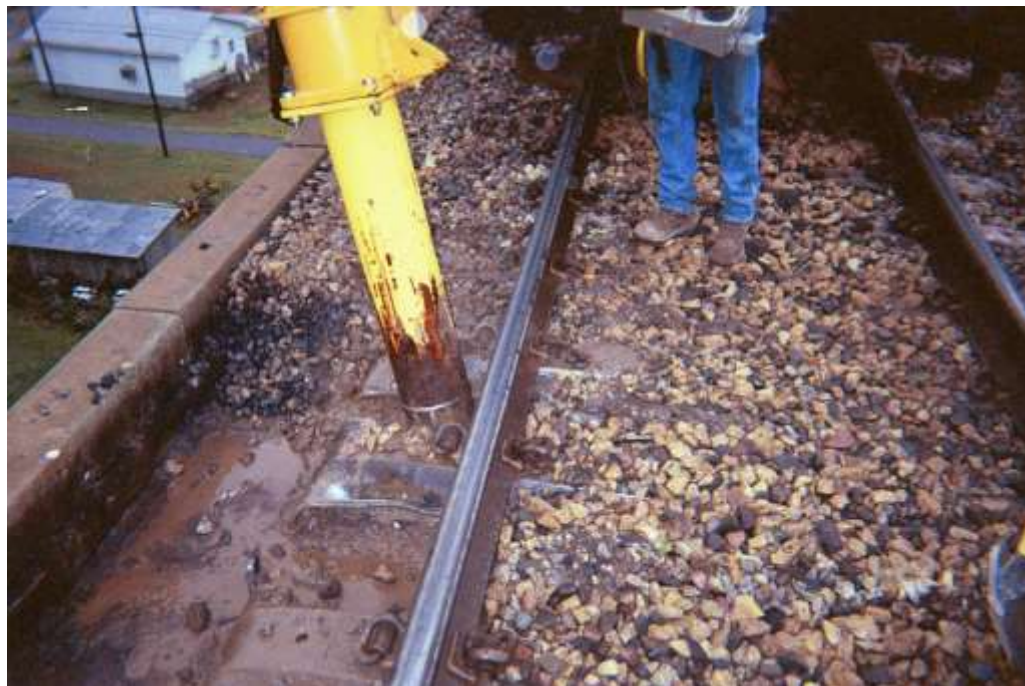
Bridge Deck Cleaning

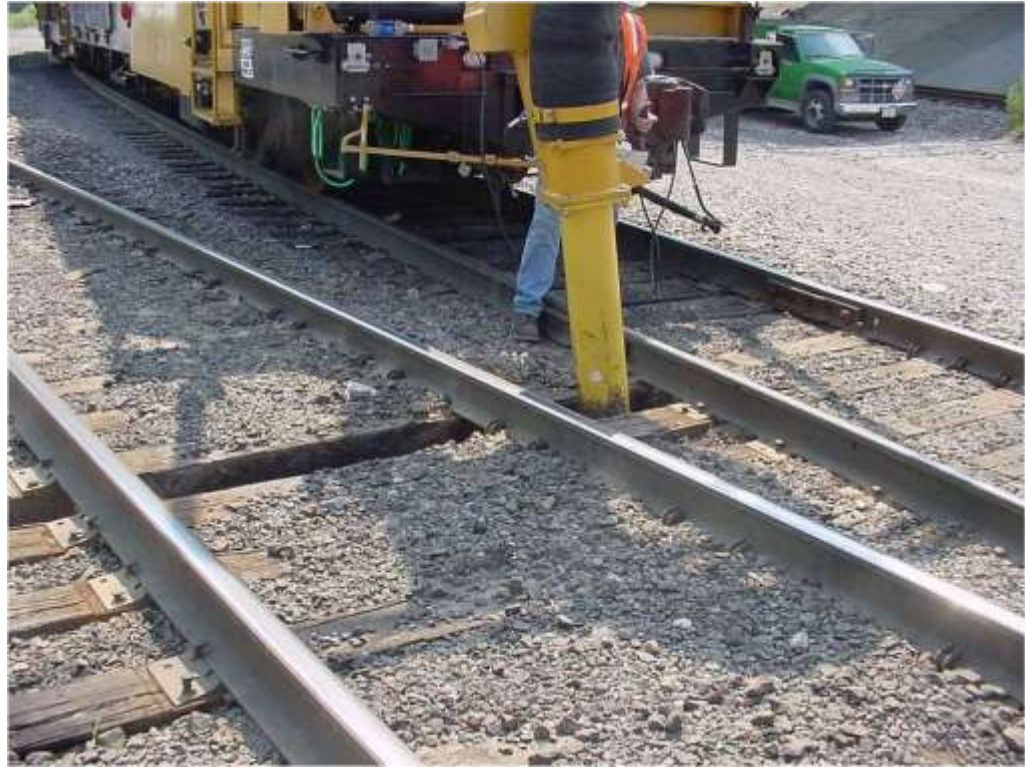
Undercutting Switch and Turnout

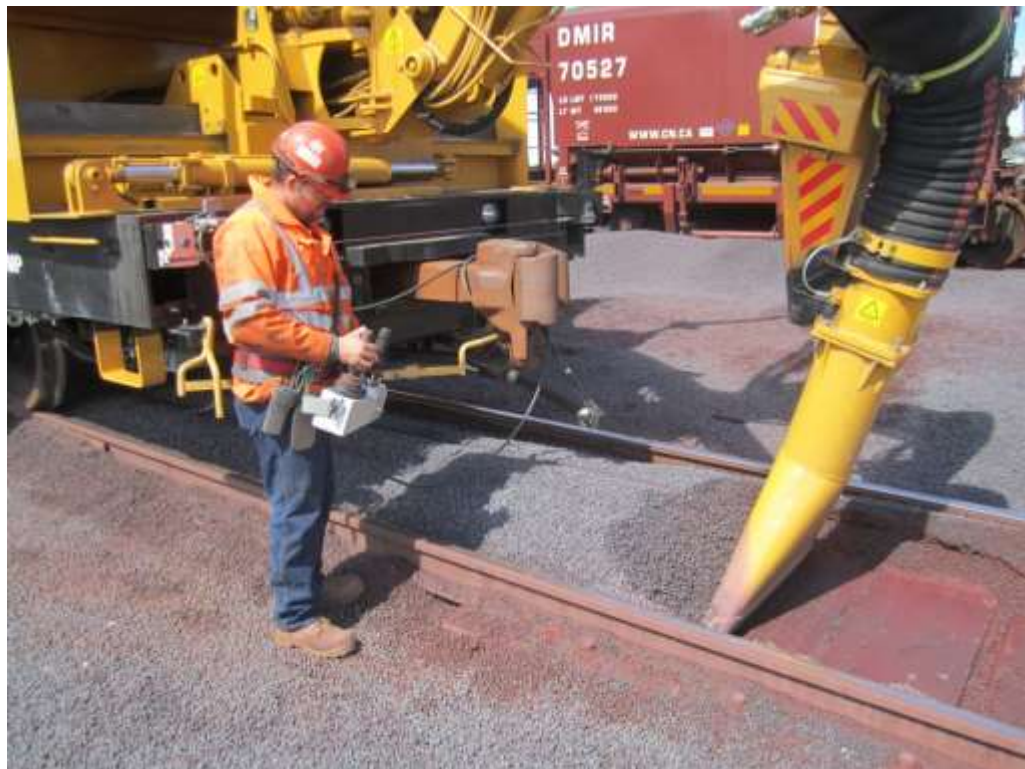
Clean Up Taconite Pellets

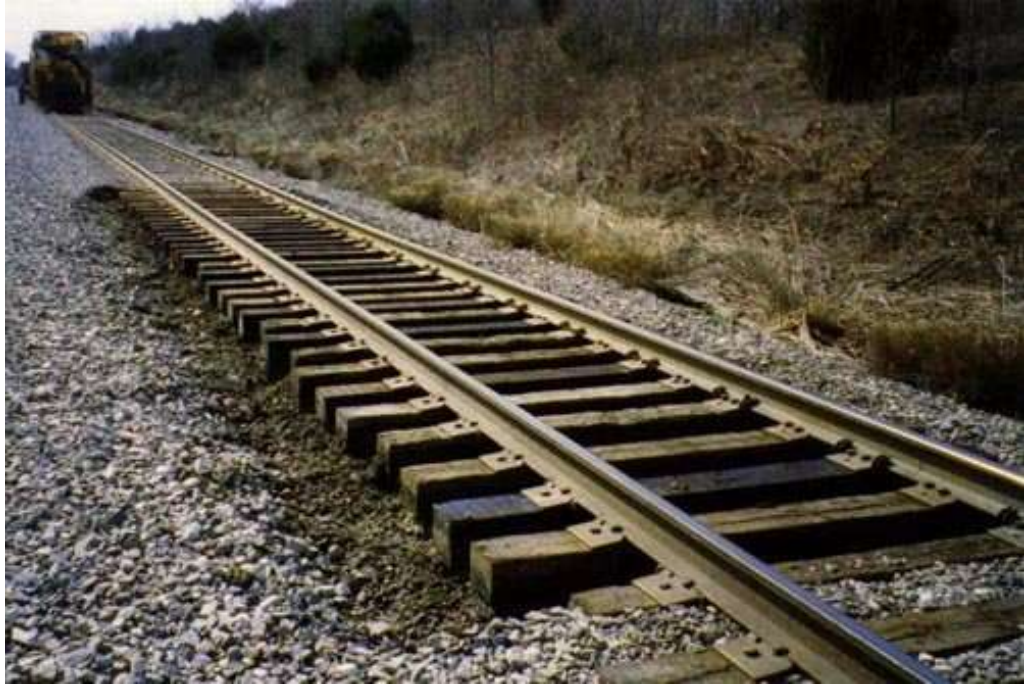
Undercut Mud Spots – Open Track
